SPECIAL INSPECTOR GENERAL FOR IRAQ RECONSTRUCTION

July 25, 2008

SUBJECT: Report on Construction of the Kahn Bani Sa'ad Correctional Facility, Kahn Bani Sa'ad, Iraq (Report Number SIGIR PA-08-138)

SIGIR PA-08-138

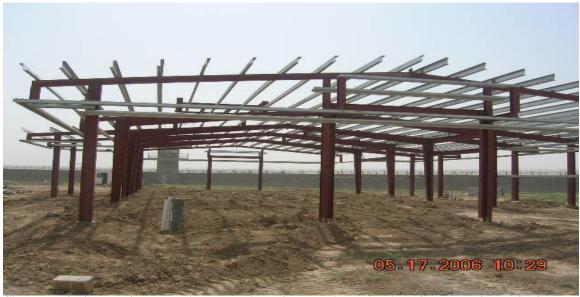
represented an "untenable 990 day schedule slippage from the schedule recovery plan [Parsons] submitted on 27 Feb in response to the Government's 17 Feb letter of concern." At the time of termination, Parsons had only partially completed the required correctional facility (Site Photos 1 and 2).

Site Photo 2. Status of construction at the time of Parsons' termination (Courtesy of the USACE)

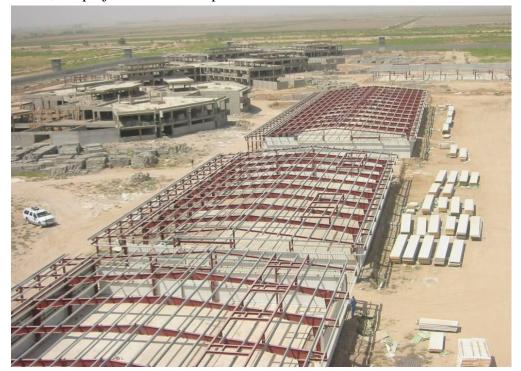
After terminating Parsons, the U.S. government believed the KBS Correctional Facility was "still required by [the] Iraqi Ministry of Justice," and awarded Contract W91GXZ-06-C-0019, a firm fixed price bridge contract, to Parsons' subcontractor to continue construction of the facility. The intent of the bridge contract was to continue construction as an interim between the Parsons contract termination and re-awarding the construction completion. Specifically, the focus was the completion of the prefabricated buildings, essential concrete pours for the superstructures, masonry work, and facility systems. The bridge contract was awarded on 19 June 2006 with a fixed period contract in the amount of \$3,299,983, which ended on 15 September 2006. When the contract was completed in September 2006, the contractor had finished the concrete pours and other miscellaneous work (Site Photo 3); however, the project was not complete.

Site Photo 3. Status of project at the end of the bridge contract (Courtesy of the USACE)

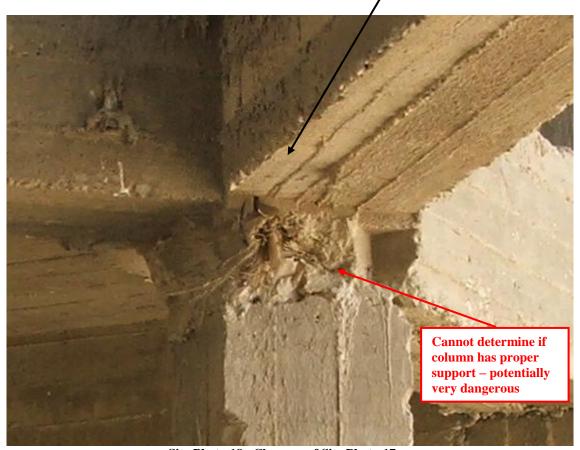
Site Photo 18. Close-up of Site Photo 17

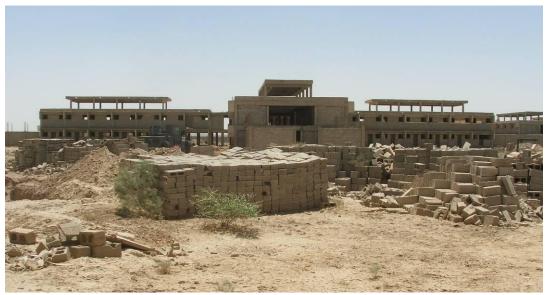
SIGIR toured the entire KBS Correctional Facility site in search of the materials reportedly left on site when the contract was terminated. Numerous cement blocks (Site Photo 21) and bundles of chain link fencing were located (Site Photo 22). In SIGIR's opinion, the majority of the \$1.2 million in materials listed by the contractor as abandoned was either not delivered to the site or removed after the contract was terminated.

Site Photo 21. Concrete blocks still on site at the KBS Correctional Facility
